75  
galvanize  
October 2014

# LOCAL ENGINEERED SOLUTIONS

# KEEPING STEEP TASK ON TRACK

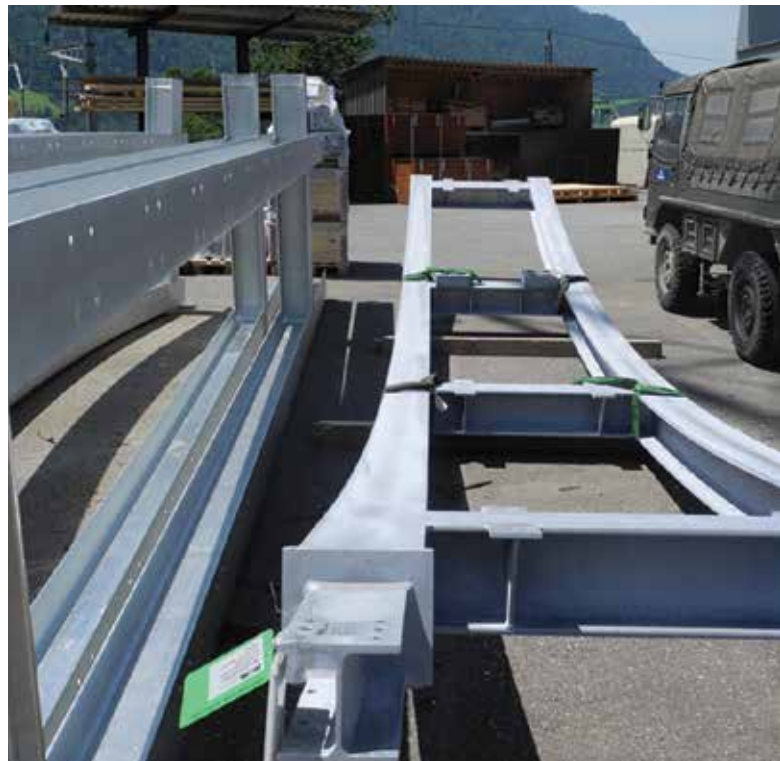
A Bell UH1H helicopter was required to handle the installation, with some sections even having to be lowered into place weaving through the complex web of the existing steel support structure, so having to reinstall components later on could prove costly.

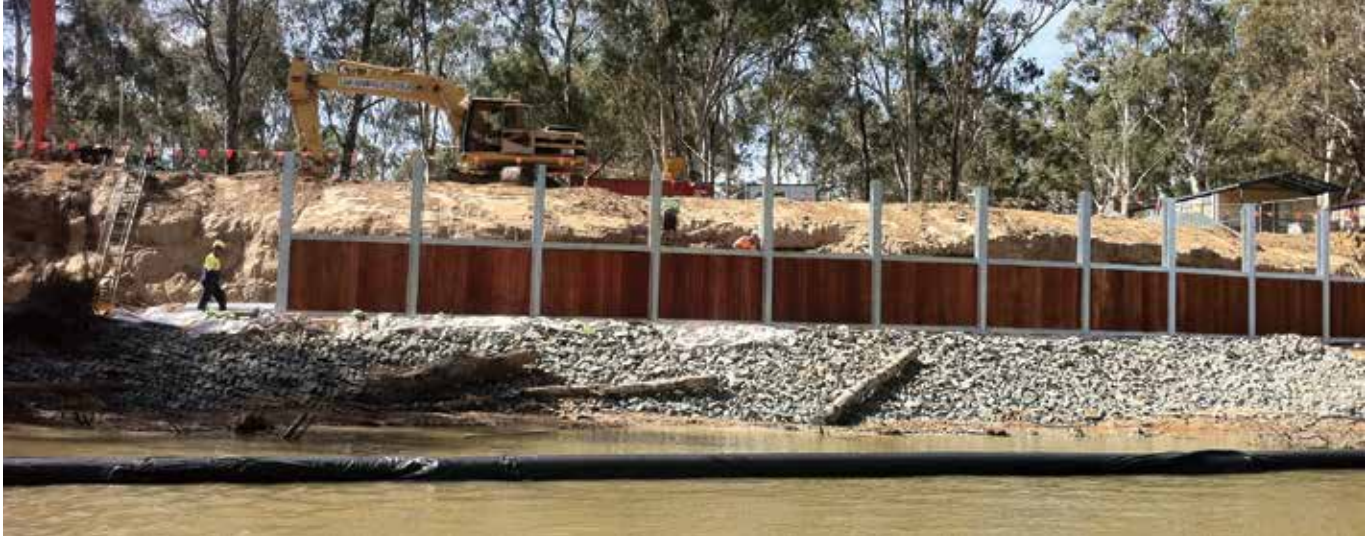
An engineered retaining wall supported by a galvanized steel frame is keeping land subsidence from encroaching on the picturesque Murray River and locals safe from floods whilst allowing red gum timber panelling to reflect the region's treasured tree life.

The 333 metre long and four metre high structural steel and timber retaining wall at the Moama-based holiday park was designed to follow the naturally winding course of the Murray River and its undulating ground level whilst also providing a more secure foundation for the established river red gums along the bank.

Project Manager **Gavan Kennaugh** of G&K Kennaugh Earthmoving said the combination of large galvanized steel columns, horizontal rails and vertical red gum sections, all sourced locally using sustainable techniques, enhance the natural surroundings while providing a structure substantial enough to meet the required function.

It was decided the project would be designed and manufactured off-site to 'bolted together' specifications, including the red gum sections that were prefabricated in the workshop into panels, transported to site and lowered into place as the wall progressed upstream.

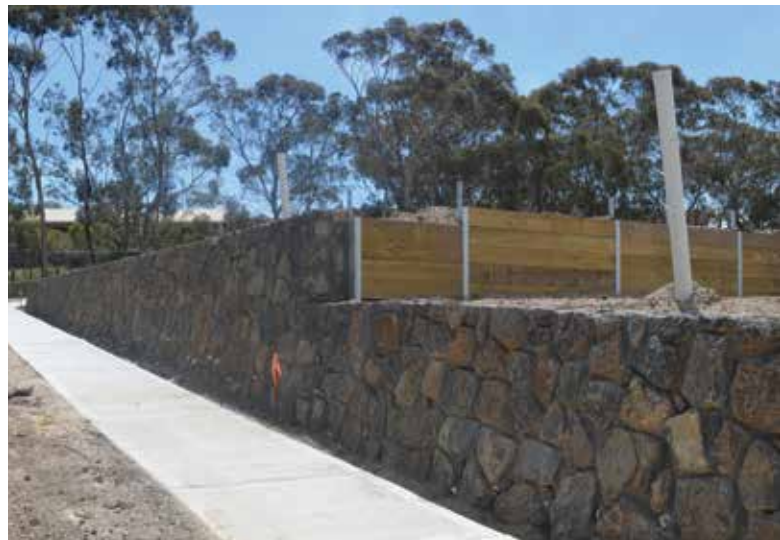
Part of the 750m long retaining wall

Both projects comprise approximately 750 metre long timber retaining walls ranging from 200mm to 2.4 metre high supported by steel 'soldiers' and concrete footings.

The galvanized sections on this project were based on several types of steel soldiers employing sections of 150UC23 150UC30 and 250UC30 grades called up by the engineering.

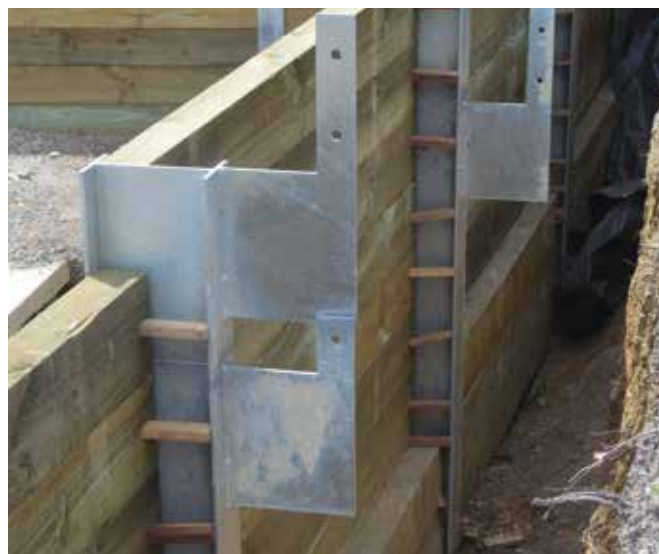
Offset fencing brackets were used to properly locate the fence on the boundary

This issue was addressed with specially designed offset fencing brackets welded to the back of the walls that enabled the retaining wall to be located inside the new property title but the fencing to be located on the title boundary.

"We also had two different types of fence cleats welded to the tops of all steel soldiers before galvanizing. One type was fabricated on top of the steel soldiers whilst the other was to the rear for title offset."

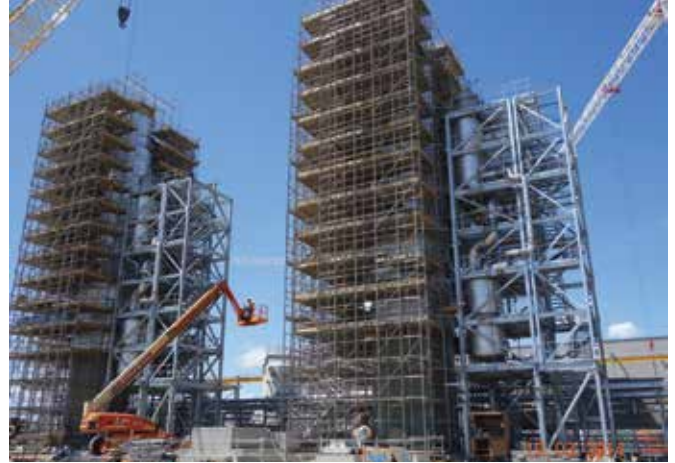
*The water treatment facility under construction*

Redispan applied its design for manufacture and assembly (DFMA) approach through a major redesign of the facility structures. Using a detailed constructability study and early engineering engagement they considered transport, lifting and temporary bracing to move as much assembly offsite as possible.

Redispan Business Development Manager, **Greg Payne** said that being able to break the buildings into transportable sections fully fitted with piping, vessels, walkways and stairs had a dramatic impact on installation time and costs.
